Feasibility Study
Abington Public Schools

Town of Abington

August 26, 2013

Frolio Middle School Building Evaluation

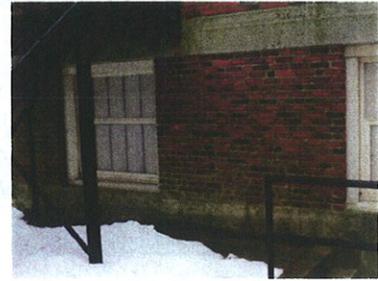
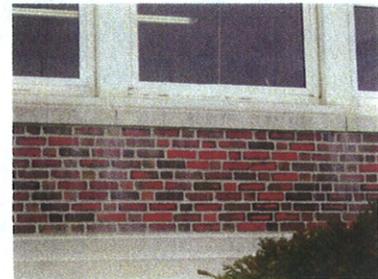
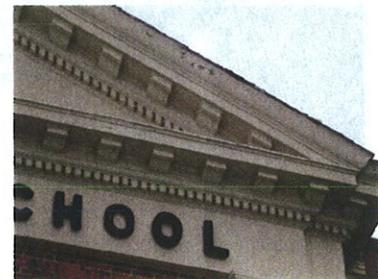
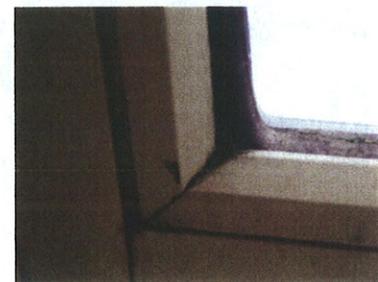
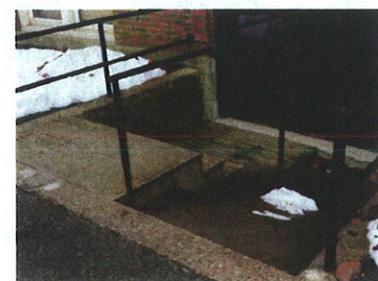
Cast stone window sill joints have deteriorated and moisture penetration is evident by staining on the adjacent brick.

The caulking around the window system has been periodically maintained. However, the deterioration of the caulking in many locations results in significant heat loss and air and water infiltration. It was observed in select locations the seal at the glazing has released to the extent that daylight and a draft can be felt.

The door to the Band Classroom sits in a well. During a significant rain storm this area tends to flood causing water infiltration into the building.

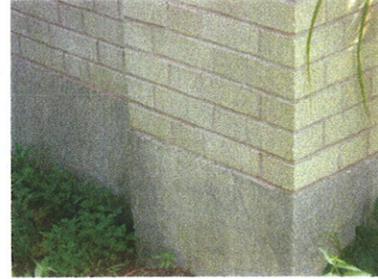
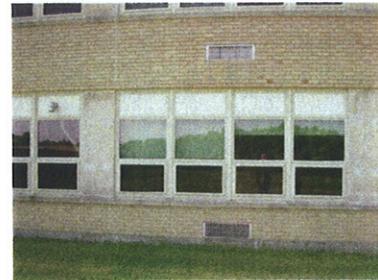
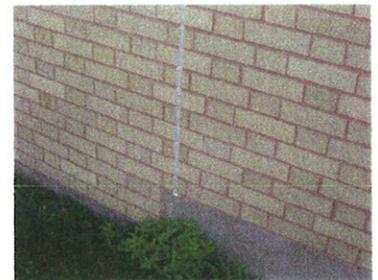
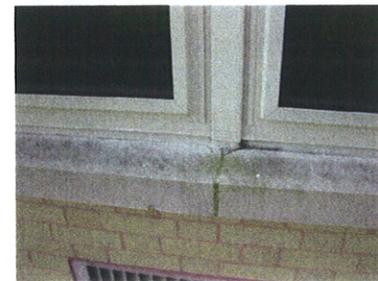
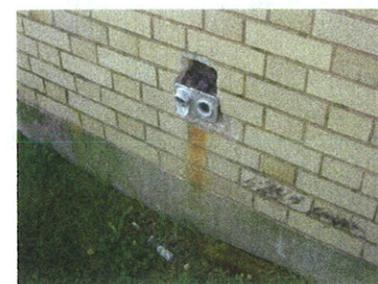
In 2007 the exterior windows of the building were replaced with a combination of fixed and hopper aluminum windows. This is a high-quality system which has done a good job stopping the deterioration of the building's exterior. Although the system represented the best of industry standards in 2007, the recent focus on energy conservation has since resulted in the Commonwealth's adoption of significantly higher energy code standards. The system remains in excellent condition; however, it is possible that portions of the system would have to be replaced if a fully compliant comprehensive renovation is completed at the facility. The system would be over 10 years old at that time, and the windows would not meet the new standards. Additionally, even more stringent energy code requirements will be in place prior to the commencement of any proposed renovations to the high school.

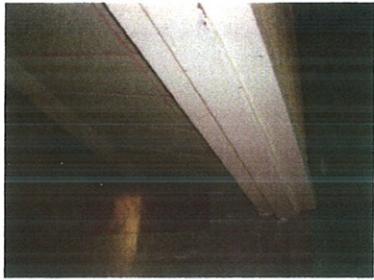
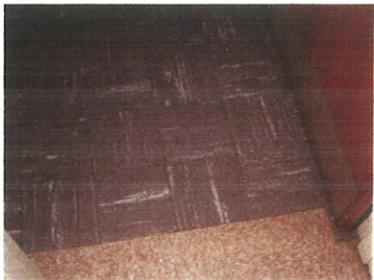
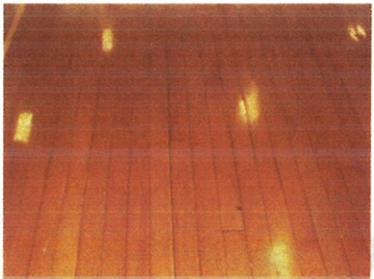
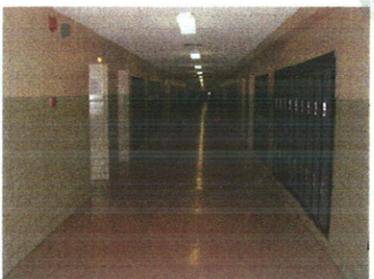
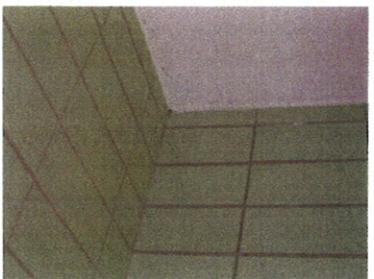
Most door hardware appears to have been replaced over time. Although the hardware has been replaced, a majority of the door hardware remains non-compliant and is further discussed in the handicap accessibility portion of this report.

There are numerous ceiling materials throughout the building. These finishes include the following: 2x4 ceiling tile (installed in select classrooms as part of lighting upgrade), 1x1 ceiling tiles, exposed painted concrete ceilings, and Tectum ceiling panels in the corridor. The age of the ceilings is apparent as modern retrofitted amenities are all exposed including wiring for power, fire alarm and lighting.
